# DAM INSPECTION CHECKLIST POSSUM POINT POWER STATION POND ABC

INSPECTION DATE: MARCH 8, 2016

INSPECTED BY: K. ACRE

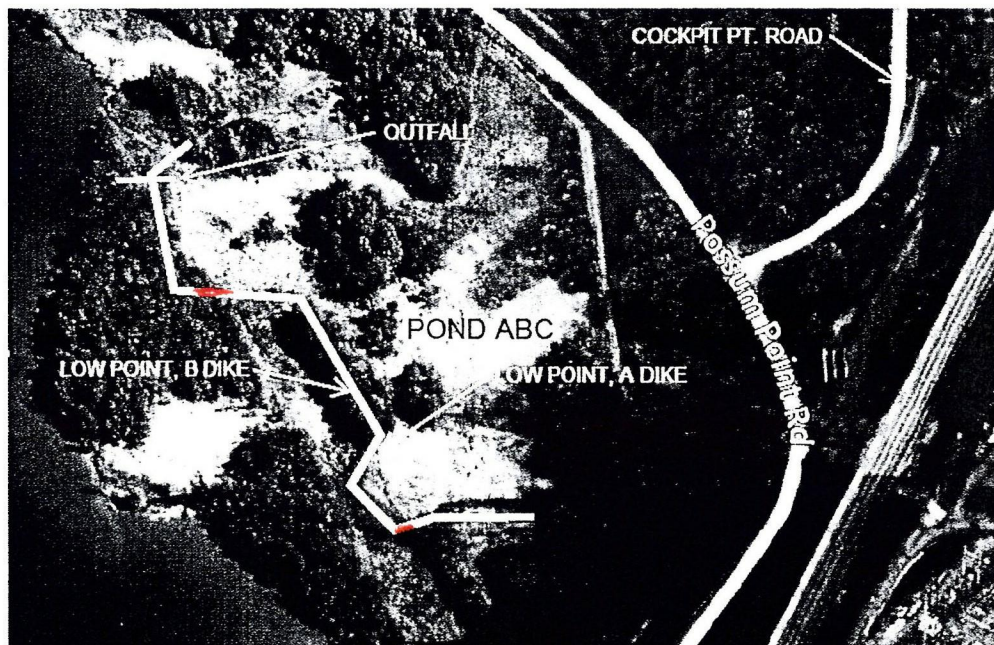
Location/ Condition	(y/n)	Change (y/n)	Comments
Low Point, A dike*			
Flow	N	N	1307 → SAND BAGS + RIPRAP IN PLACE, AND NO STANDING WATER AGAINST SAND BAGS.
Erosion	N	N	SEVERAL SAND BAGS ARE RIPPED.
Low Point, B dike*			
Flow	N	N	1312 → SAND BAGS ARE IN PLACE AND THERE IS <del>NO</del> NO STANDING WATER AGAINST SAND BAGS.
Erosion	N	N	
Outfall			
water surface El. (top of stoplogs to water)			1318 → NO FLOW THROUGH WEIR, NO STANDING WATER AGAINST WEIR, AND WEIR APPEARS TO BE DRY.

**Additional Comments (Note any changes observed along the embankment crest or downstream slope observed from the crest.):** → STANDING WATER AT TOP OF EMBANKMENT TO PONDS A, B, C. AS NOTED IN FIGURE BELOW.

(1318) → LOW POINT, C DIKE → NO FLOW OR EROSION, NO STANDING WATER AGAINST SAND BAGS, SAND BAGS ARE IN PLACE, AND SEVERAL SAND BAGS ARE RIPPED.  
→ STANDING WATER AGAINST AT INSIDE TOE OF EMBANKMENT TO POND C, SOME STANDING WATER AT INSIDE TOE TO EMBANKMENT FOR PONDS A & B, AS WELL.
